Z-2 Threaded Insert Design and Testing

Amy Ross¹ and Richard Rhodes²
NASA Johnson Space Center, Houston, TX 77058

NASA's Z-2 prototype space suit contains several components fabricated from an advanced hybrid composite laminate consisting of IM10 carbon fiber and fiber glass. One requirement was to have removable, replaceable helicoil inserts to which other suit components would be fastened. An approach utilizing bonded in inserts with helicoils inside of them was implemented. During initial assembly, cracking sounds were heard followed by the lifting of one of the blind inserts out of its hole when the screws were torqued. A failure investigation was initiated to understand the mechanism of the failure. Ultimately, it was determined that the pre-tension caused by torquing the fasteners is a much larger force than induced from the pressure loads of the suit which was not considered in the insert design. Bolt tension is determined by dividing the torque on the screw by a k value multiplied by the thread diameter of the bolt. The k value is a factor that accounts for friction in the system. A common value used for k for a non-lubricated screw is 0.2. The k value can go down by as m

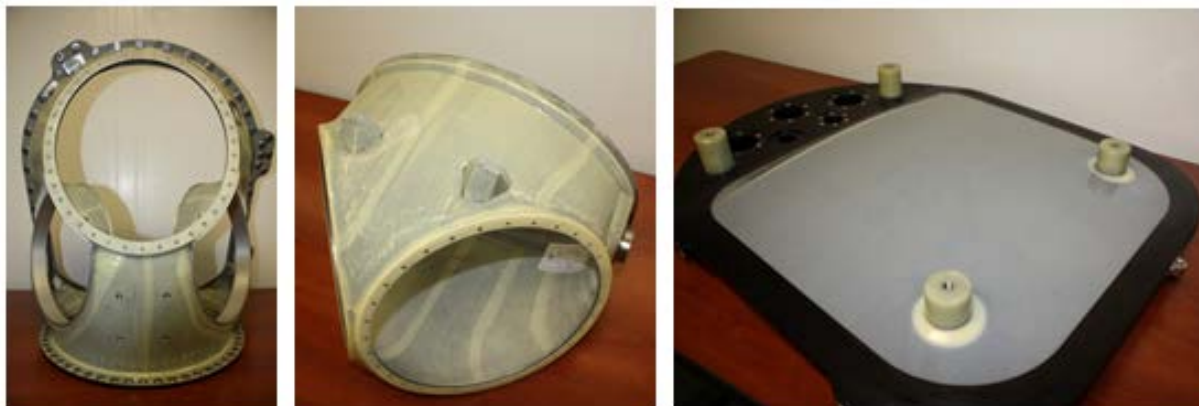
Figure 1. Z-2 Composite Components As Fabricated. *The HUT, Brief and Hatch.*

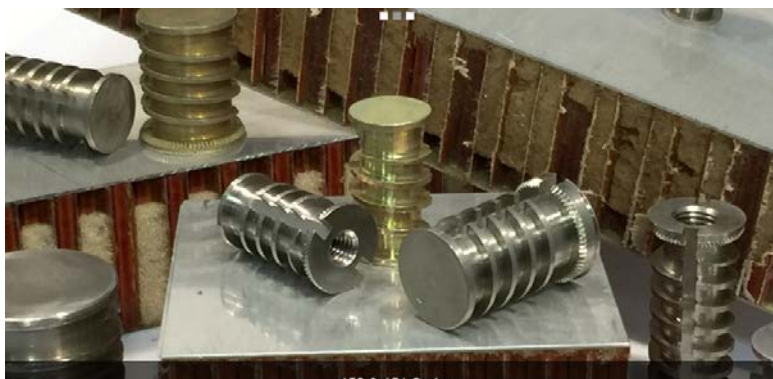
Investigation into industry standards revealed that Witten inserts have either a diamond knurl or an annular ring or flange to resist pull-out. Some also have flats on the bottom flange to resist torque-out. The heavy duty Witten fastener inserts have a spiral rib for pull-out (Figure 4).

Figure 4. Witten Inserts. Benchmarking shows COTS inserts have features on the outside of the cylinder to provide more locking interfaces.

Witten and Henkle, the manufacturer of Hysol, were contacted to discuss this failure and determine what recommendations they had to improve the results of the bond strength. Witten recommended media blasting the inserts with 300-500 grit alumina oxide powder and adding either a knurling or groove features to the outside of the inserts. Henkle recommended only adding 0.5% microspheres to the epoxy and commented that anything higher would reduce the adhesive strength. Henkle also recommended preparing the bonded surfaces with an IPA wipe to both degrease and clean and that a bond line thickness of 0.005" to 0.040" would be acceptable to achieve the full strength of the adhesive.
